# Bathing Water Profile

PROFILE 16 – Data updated for 2025

MELLIEHA: Ghadira Bay

## Update to the Bathing Water Profile based on the report by the European Environment Agency issued in May 2026

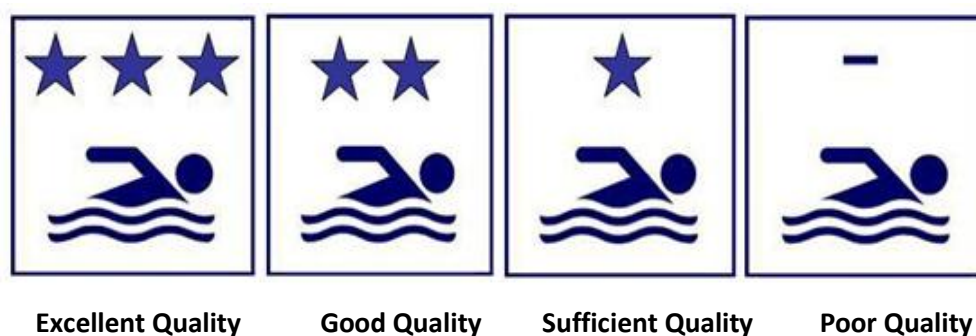
Figure 1: Star Classification

The bathing water quality is based on two microbiological parameters (Escherichia coli and Intestinal enterococci). These two parameters determine the classification of the bathing water quality as 'excellent', 'good', 'sufficient' or 'poor'. The symbols shown in **Figure 1** below correspond to this classification. The European Environment Agency report for the year 2025 indicated that 88.5% of the bathing water classified as excellent quality, see **Figure 3**. (European Environmental Agency, 2026).

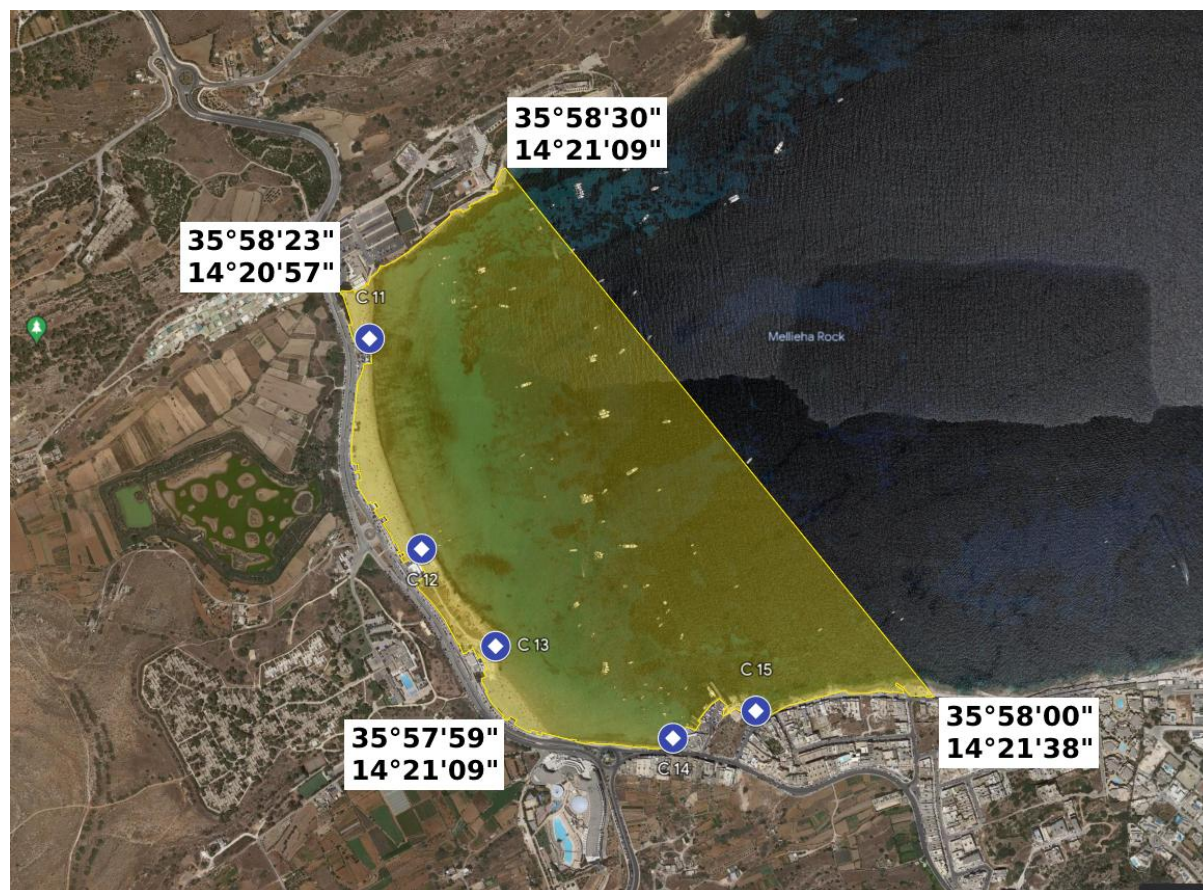
**Figure 2: GIS for the Official Bathing Area of C11, C12, C13, C14& C15**

Bathing water profile 16 covers 6 monitoring points situated in the locality of Mellieha as per **Figure 2 and Table 1**. Located along Malta's northern coast in Triq I-Marfa Mellieha. This is the largest sandy beach in Malta situated adjacent to the Natural Reserve which was set up in 1978 to protect migratory birds. The reserve provides wetland and salt marsh habitats. The bay is surrounded by a u-shaped

The monitoring points C11, C12, C13, C14 & C15 have been monitored for 23 weeks, by the Environmental Health Directorate. The monitoring period for the official bathing season starts on the third week of May till the third week of October. For the year 2025 the monitoring day where 12<sup>th</sup> May till 19<sup>th</sup> October.

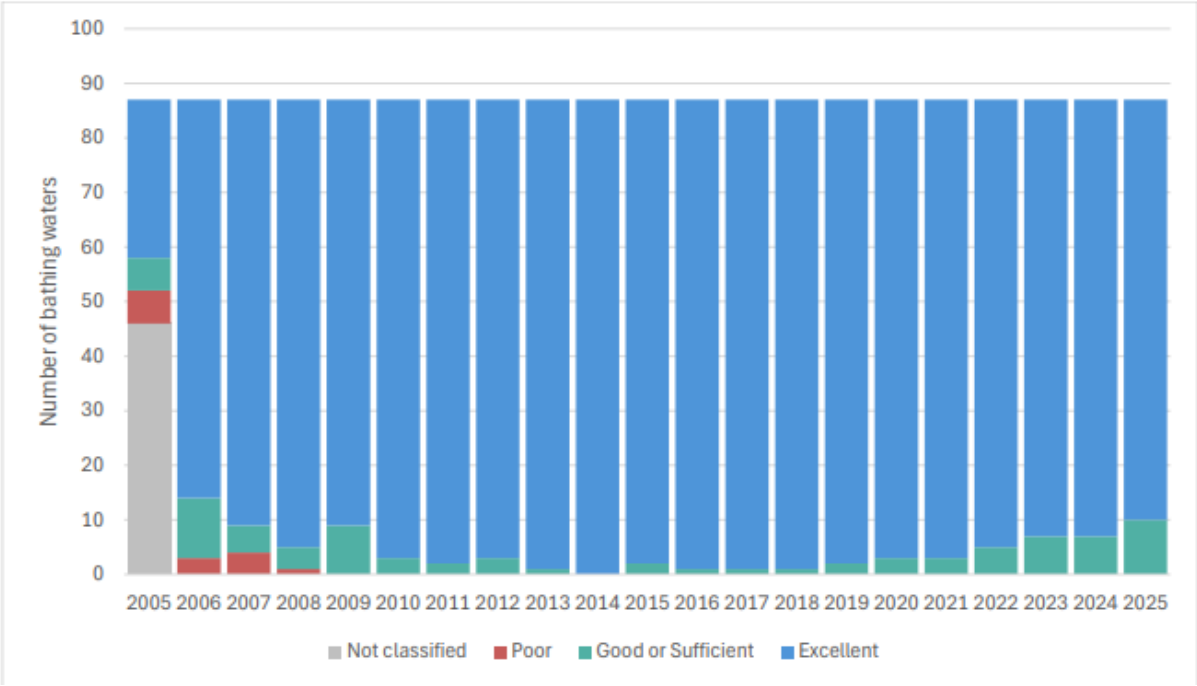
Figure 3: Results of bathing water quality in Malta from 2005 to 2025

Classification updated for the year 2025.

**Trend of coastal bathing water quality in Malta.** Notes: Each column represents an absolute number of bathing waters in the season. The ‘good’ and ‘sufficient’ quality classes are merged for comparability with the classifications under the preceding Bathing Water Directive 76/160/EEC.
