# Bathing Water Profile

PROFILE 19 – Data updated for 2025

SAN PAWL IL BAHAR: St Paul's Bay Waterfront (Bognor)

## Update to the Bathing Water Profile based on the report by the European Environment Agency issued in May 2026

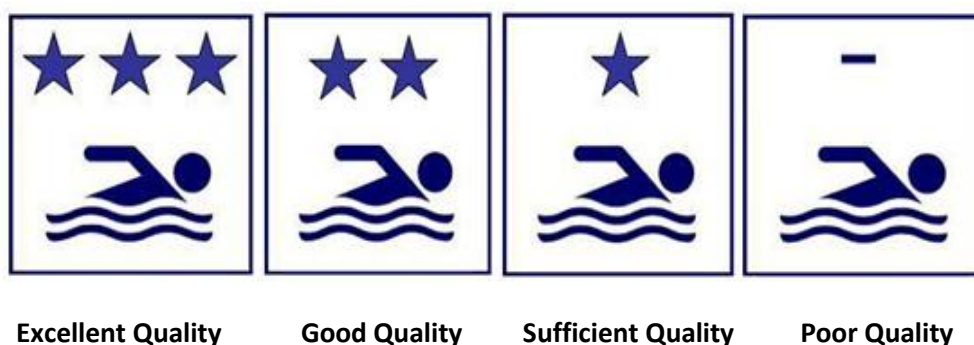
Figure 1: Star Classification

The bathing water quality is based on two microbiological parameters (Escherichia coli and Intestinal enterococci). These two parameters determine the classification of the bathing water quality as 'excellent', 'good', 'sufficient' or 'poor'. The symbols shown in **Figure 1** below correspond to this classification. The European Environment Agency report for the year 2025 indicated that 88.5% of the bathing water classified as excellent quality, see **Figure 3**. (European Environmental Agency, 2026).

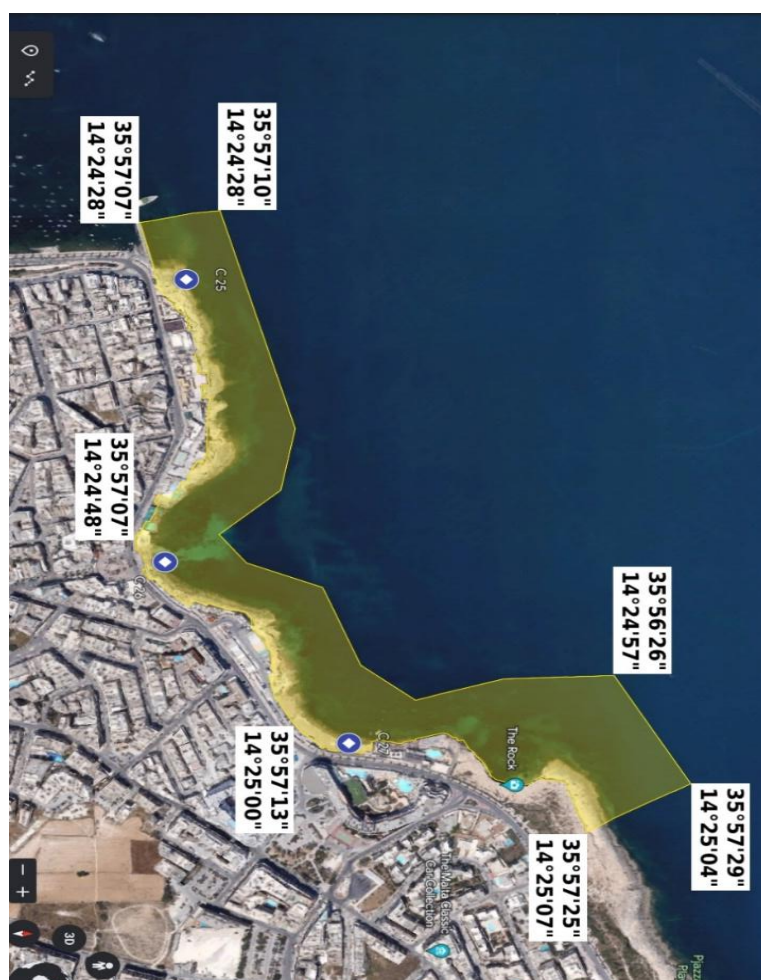
Figure 2: GIS for the Official Bathing Area of C25, C26 & C27

Bathing water profile 19 covers 3 monitoring points situated in the locality of San Pawl il-Bahar as per **Figure 2 and Table 1**. Located along Malta's northeastern coast at the beginning of Bugibba promenade. C25 is a rocky beach with Roman Salt Pans and a breakwater. While C26 and C27 a linear rocky shore with a sharp rock surface. In 2006, C27 was replenished with artificial sand. These ste are surrounded by a

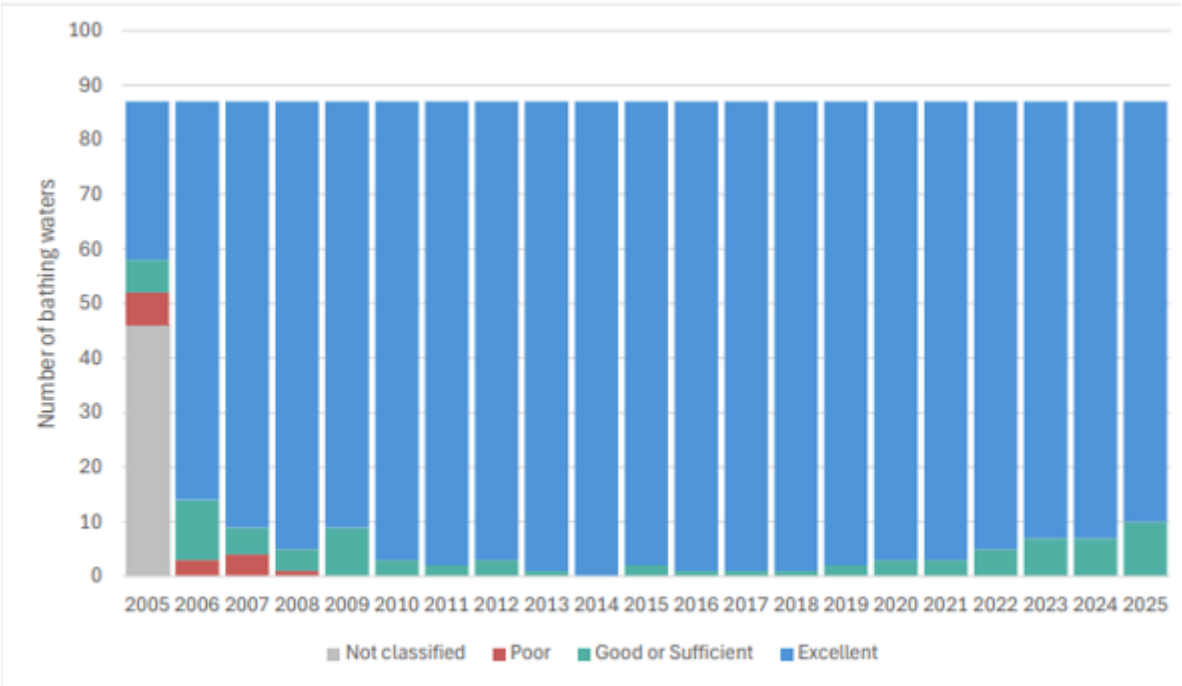
Figure 3: Results of bathing water quality in Malta from 2005 to 2025

**Trend of coastal bathing water quality in Malta.** Notes: Each column represents an absolute number of bathing waters in the season. The ‘good’ and ‘sufficient’ quality classes are merged for comparability with the classifications under the preceding Bathing Water Directive 76/160/EEC.
