## REPORT ON THE TEMPORARY CLOSURE DUE TO BATHING PROHIBATION PERIOD

**A16- Wied iz-Zurrieq Qrendi**  
**(9<sup>th</sup> – 18<sup>th</sup> August 2025)**

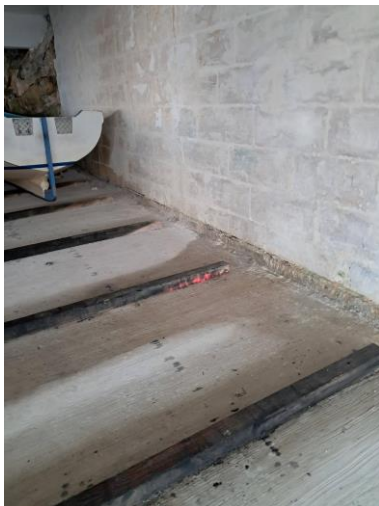
An onsite investigation was carried out by Environmental Health Officers (EHOs) at 7:00 AM on 9th August 2025 where it was confirmed that an overflow of sewage into the sea had likely occurred during the night. At the time of inspection, the overflow had stopped, but the area remained damp, as shown in Figures 1–3.

Figure 1: Origin of overflow

Following the confirmation, the EHOs were notified, and the EHD issued an Emergency Prohibition Order. The premises was prohibited from operating until the cesspits was rendered leak-proof.

Remedial works on the cesspits were carried out on 14th August 2025. A pressure test conducted on 16th August confirmed that the cesspits was leak-proof, and the Emergency Prohibition Order was subsequently lifted.

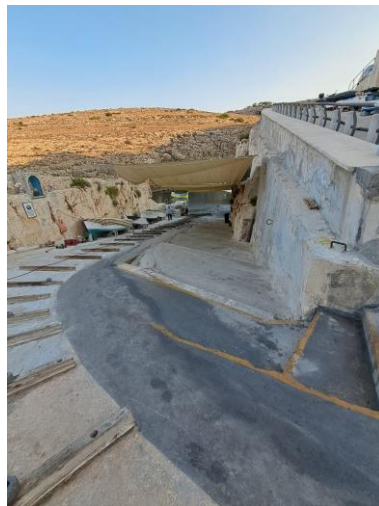
Figure 2: Overflow into the street

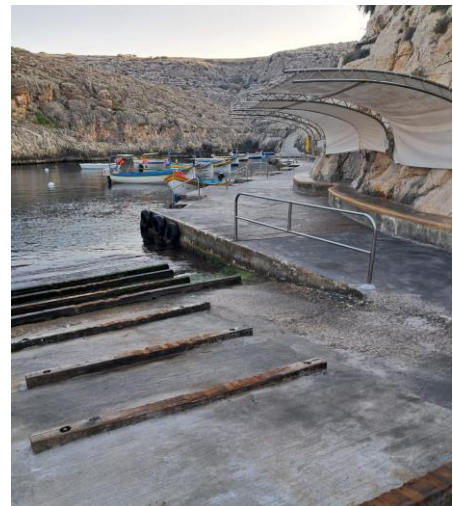
Figure 3: Overflow ending into the sea

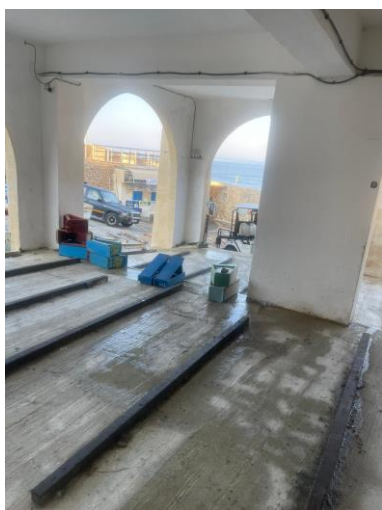
On 12th August, the overflow resumed. A colour test was conducted at a private property with a drainage system connected to a cesspit. Approximately one hour after the test began, the coloured water was observed overflowing into the street, which led directly to the bathing water.

Figure 4: Area of overflow

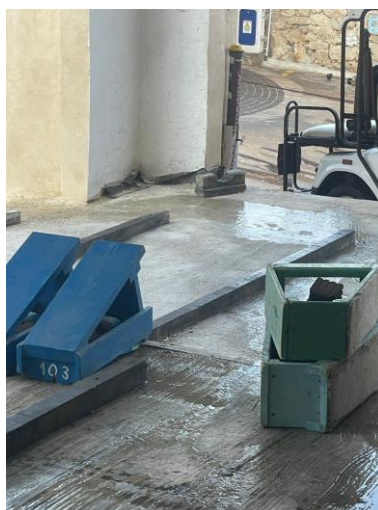
Figure 5: Area of overflow

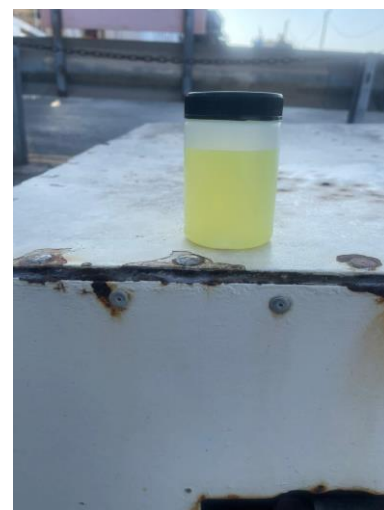
Samples were taken both before and after the test to assess sewage contamination and the presence of fluorescein. The results confirmed sewage contamination in both samples, and fluorescence was only visible in the post-test sample, confirming a link between the property's drainage system and the overflow.

Figure 6: Sample with visible fluorescence colour

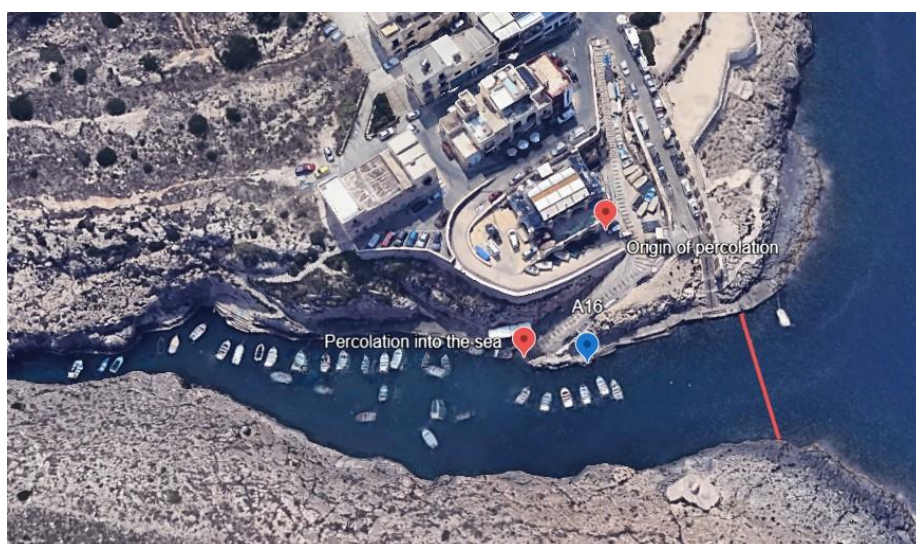
The map below indicating the affected area.

Figure 7: Site map

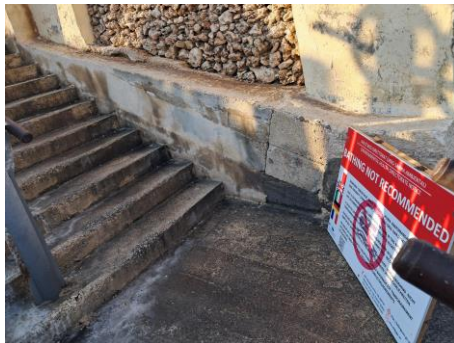
Public information signs indicating that the bathing area is temporary closed were also affixed by the EHOs (as below photos).

Figure 8: Sign not recommend for bathing

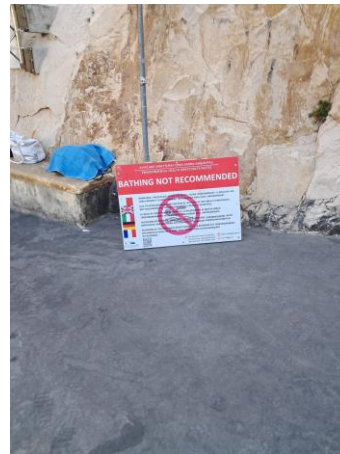
Figure 9: Sign not recommended for bathing
