# Bathing Water Profile

PROFILE 11 – Data updated for 2025

IMGARR: Gnejna Bay

## Update to the Bathing Water Profile based on the report by the European Environment Agency issued in May 2026

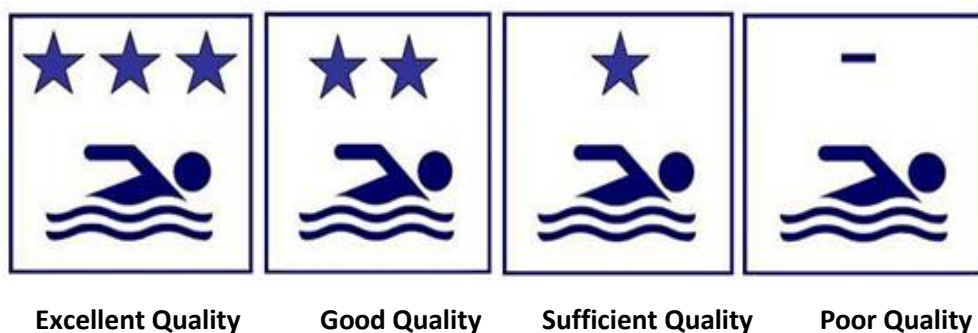
Figure 1: Star Classification

The bathing water quality is based on two microbiological parameters (Escherichia coli and Intestinal enterococci). These two parameters determine the classification of the bathing water quality as 'excellent', 'good', 'sufficient' or 'poor'. The symbols shown in **Figure 1** below correspond to this classification. The European Environment Agency report for the year 2025 indicated that 88.5% of the bathing water classified as excellent quality, see **Figure 3**. (European Environmental Agency, 2026).

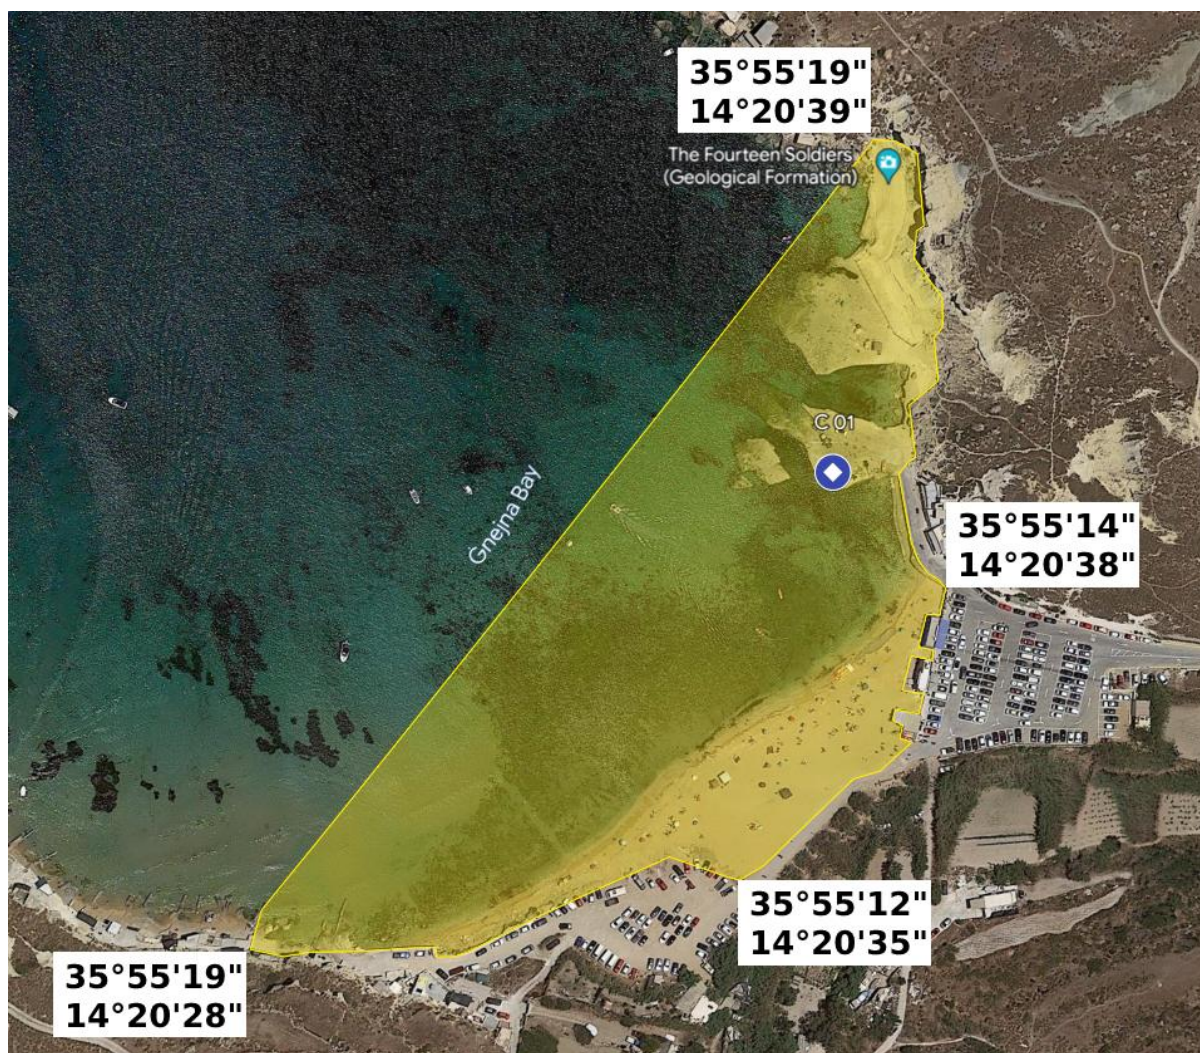
Figure 2: GIS for the Official Bathing Area of C01

Bathing water profile 11 covers 1 monitoring point situated in the locality of Imgarr as per **Figure 2 and Table 1**. Located along Malta's western coast, the inlet of Ġnejna Bay, Imgarr forms part of the landward valley. On the side of this sandy beach with cobbled stones there is a cemented area. The area is surrounded by

agricultural fields and next to the shore there are boat houses and kiosk.

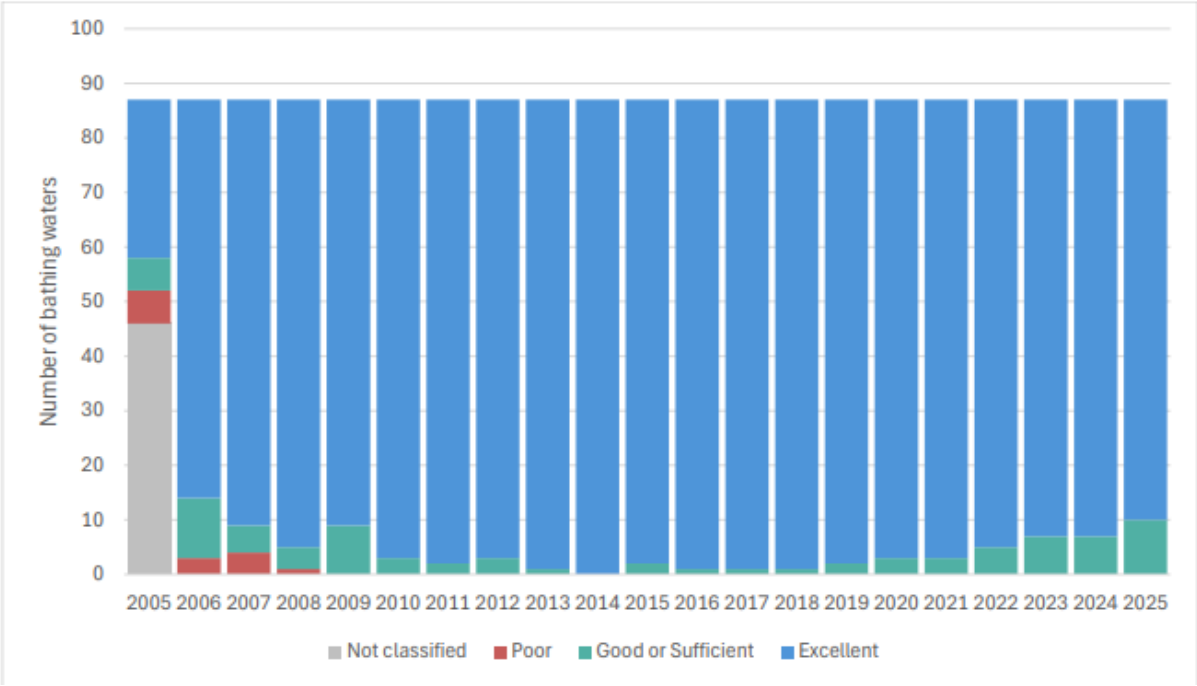
Figure 3: Results of bathing water quality in Malta from 2005 to 2025

Classification updated for the year 2025.

**Trend of coastal bathing water quality in Malta.** Notes: Each column represents an absolute number of bathing waters in the season. The ‘good’ and ‘sufficient’ quality classes are merged for comparability with the classifications under the preceding Bathing Water Directive 76/160/EEC.
