# Bathing Water Profile

PROFILE 14– Data updated for 2025

MELLIEHA: Paradise Bay

## Update to the Bathing Water Profile based on the report by the European Environment Agency issued in May 2026

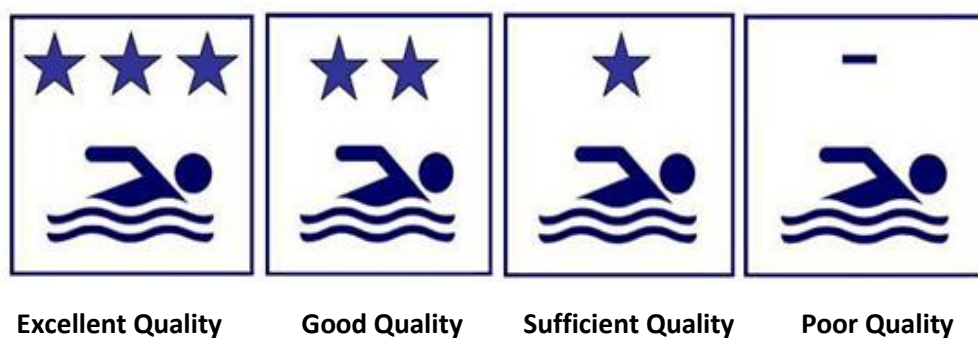
Figure 1: Star Classification

The bathing water quality is based on two microbiological parameters (Escherichia coli and Intestinal enterococci). These two parameters determine the classification of the bathing water quality as 'excellent', 'good', 'sufficient' or 'poor'. The symbols shown in **Figure 1** below correspond to this classification. The European Environment Agency report for the year 2025 indicated that 88.5% of the bathing water classified as excellent quality, see **Figure 4**. (European Environmental Agency, 2026).

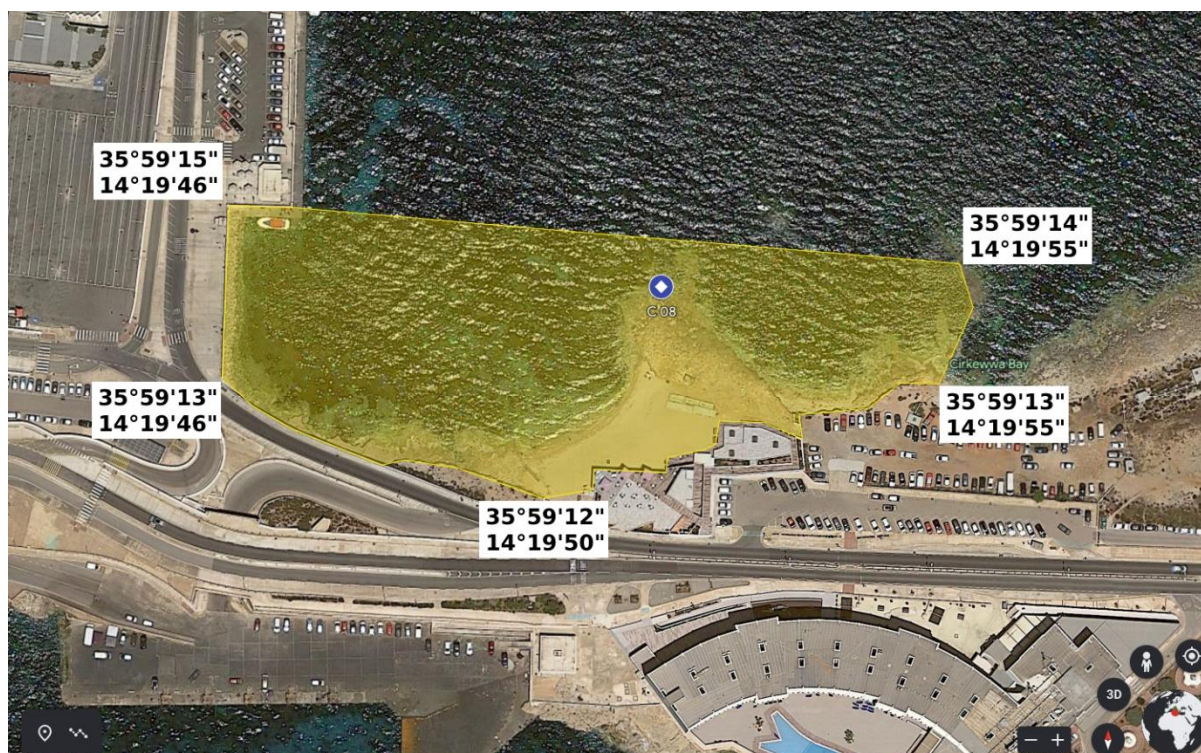
**Figure 1: GIS for the Official Bathing Area of C08**

Bathing water profile 14 covers 2 monitoring points situated in the locality of Mellieha as per **Figure 2 & 3 and Table 1**. Located along Malta's northern coast of Cirkewwa. C07 is accessible from a steep stair adjacent to the parking area in Triq il Latinja. The picturesque site consists of a small sandy beach within a natural cove and rugged cliff-side scenery. C08 is in the vicinity of the Gozo ferry terminal and adjacent to Triq il-

Marfa. This sandy beach overlooks the islands of Comino and Gozo and is also predominantly composed of sand and rocky coastline.

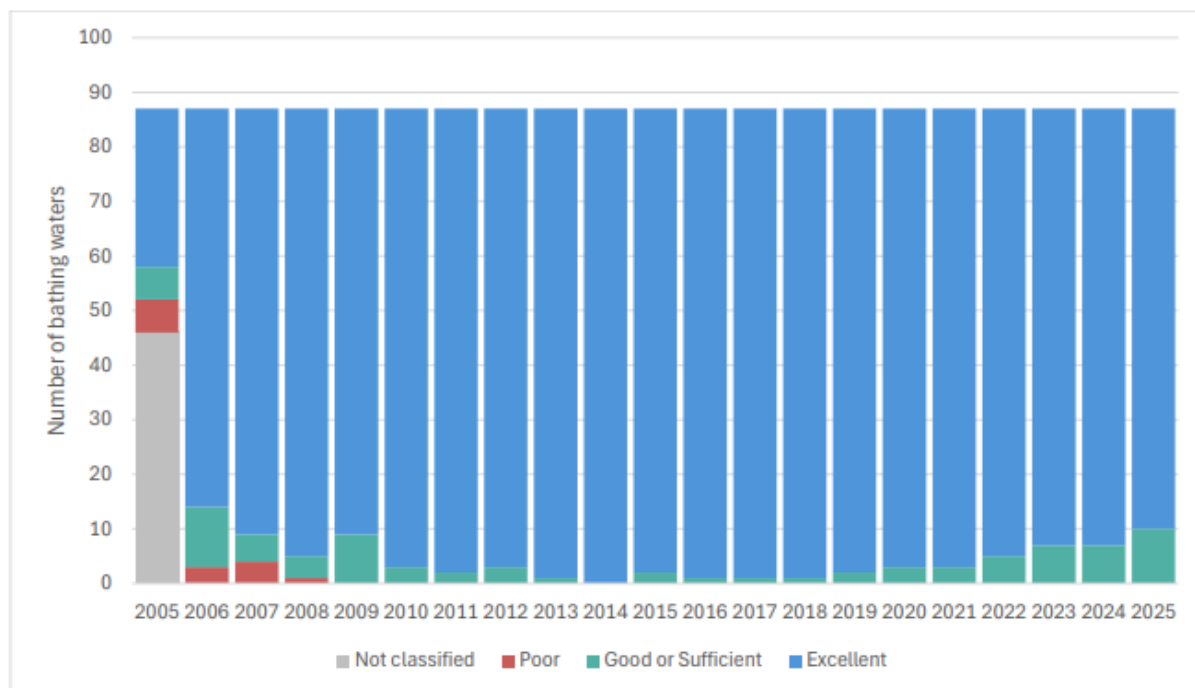
Figure 4: Results of bathing water quality in Malta from 2005 to 2025

Classification updated for the year 2025.

**Trend of coastal bathing water quality in Malta.** Notes: Each column represents an absolute number of bathing waters in the season. The 'good' and 'sufficient' quality classes are merged for comparability with the classifications under the preceding Bathing Water Directive 76/160/EEC.
