# Bathing Water Profile

PROFILE 15 – Data updated for 2025

MELLIEHA: Armier

## Update to the Bathing Water Profile based on the report by the European Environment Agency issued in May 2026

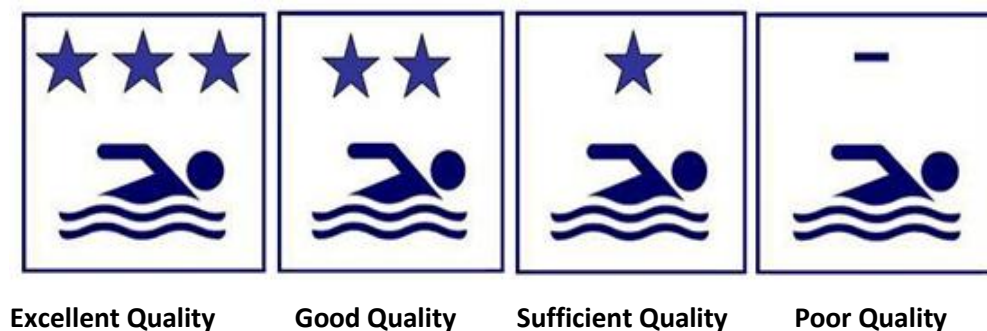
Figure 1: Star Classification

The bathing water quality is based on two microbiological parameters (Escherichia coli and Intestinal enterococci). These two parameters determine the classification of the bathing water quality as 'excellent', 'good', 'sufficient' or 'poor'. The symbols shown in **Figure 1** below correspond to this classification. The European Environment Agency report for the year 2025 indicated that 88.5% of the bathing water classified as excellent quality, see **Figure 3**. (European Environmental Agency, 2026).

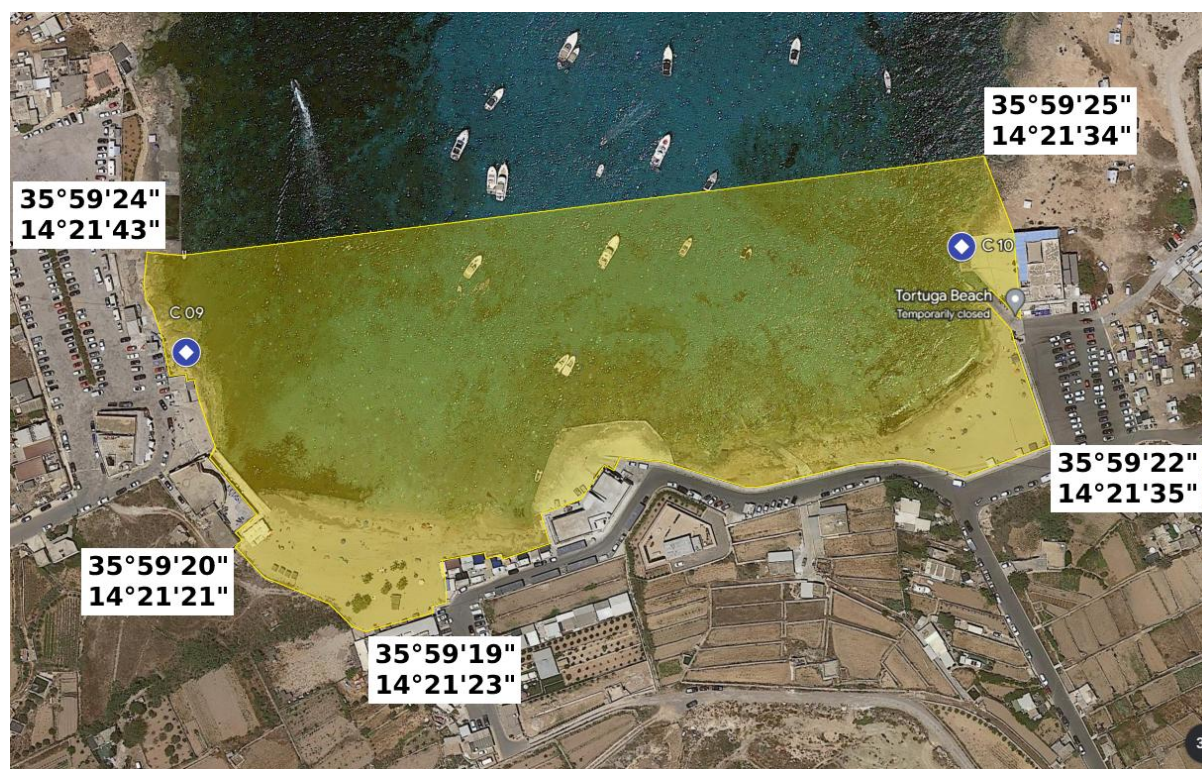
Figure 2: GIS for the Official Bathing Area of C09 & C10

Bathing water profile 15 covers 2 monitoring points situated in the locality of Mellieha as per **Figure 2 and Table 1**. Located in the northern coast most part of Malta C09 is adjacent to Triq Ramlet il-Qortin while C10 is situated in Triq l-Armier Mellieha. Both monitoring points are sandy beaches with a rocky coast. The surrounding landscape presents a rustic setting

with several rubble walls and corbelled huts. The area is surrounded by lido and kiosk.

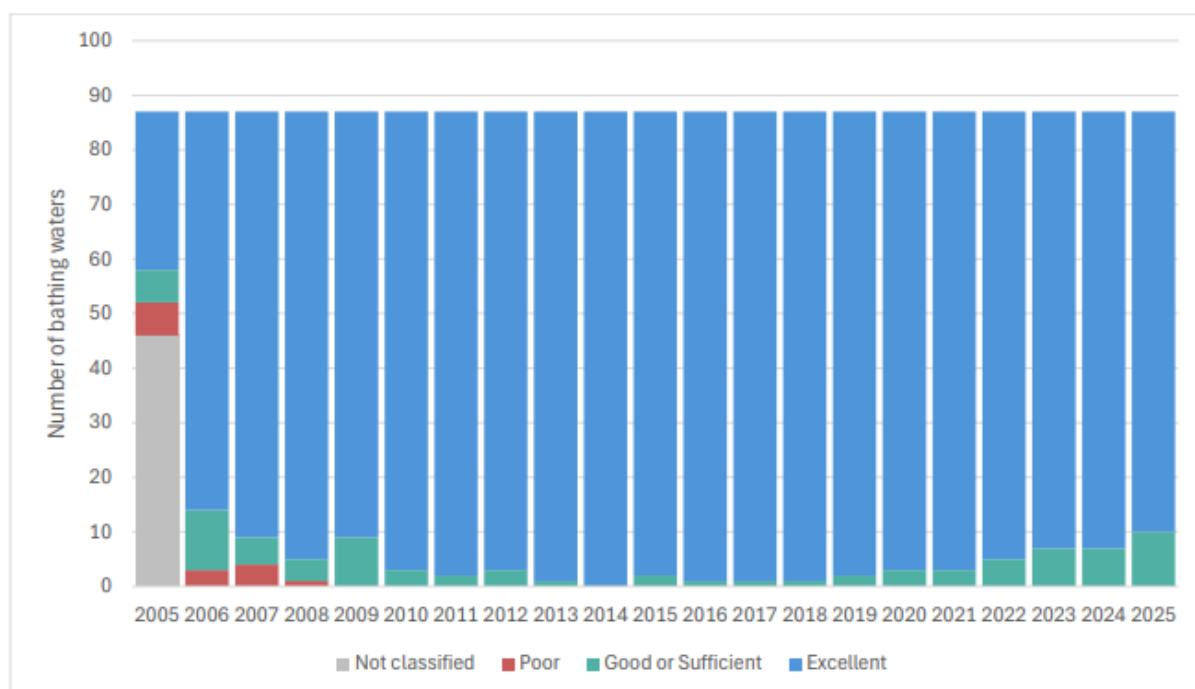
Figure 3: Results of bathing water quality in Malta from 2005 to 2025

Classification updated for the year 2025.

**Trend of coastal bathing water quality in Malta.** Notes: Each column represents an absolute number of bathing waters in the season. The 'good' and 'sufficient' quality classes are merged for comparability with the classifications under the preceding Bathing Water Directive 76/160/EEC.
