PROFILE 20 – Data updated for 2025

SAN PAWL IL BAHAR: Qawra Point

## Update to the Bathing Water Profile based on the report by the European Environment Agency issued in May 2026

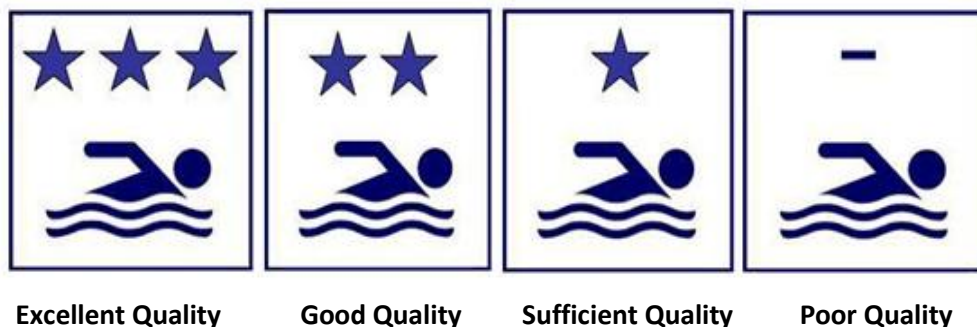
Figure 1: Star Classification

The bathing water quality is based on two microbiological parameters (*Escherichia coli* and *Intestinal enterococci*). These two parameters determine the classification of the bathing water quality as 'excellent', 'good', 'sufficient' or 'poor'. The symbols shown in **Figure 1** below correspond to this classification. The European Environment Agency report for the year 2025 indicated that 88.5% of the bathing water classified as excellent quality, see **Figure 4**. (European Environmental Agency, 2026).

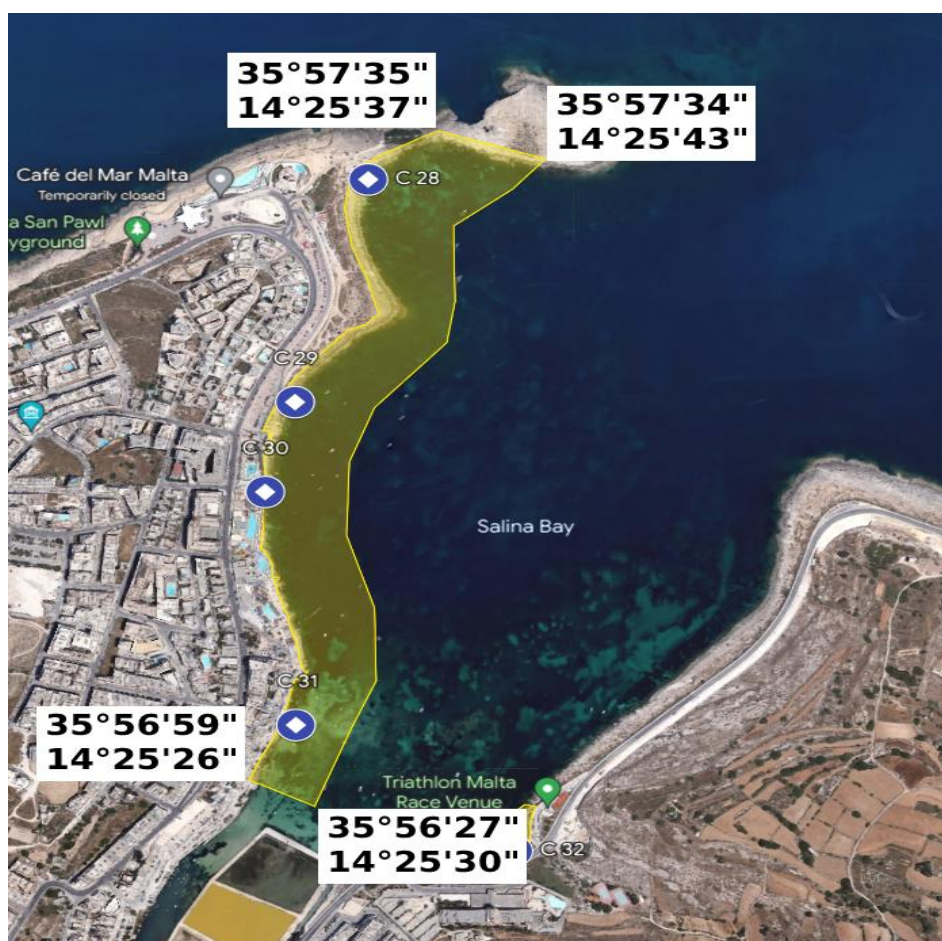
Figure 2: GIS for the Official Bathing Area of C28, C29, C30 & C31

Bathing water profile 20 covers 5 monitoring points situated in the localities of San Pawl il-Bahar and Naxxar as per **Figure 2 & 3 and Table 1**. Monitoring points from C28 to C31 are located along Malta's northeastern coast adjacent to the Bugibba/Qawra Promenade. A rocky shore surrounded by restaurants, hotels and private dwellings. C32 is a small sandy

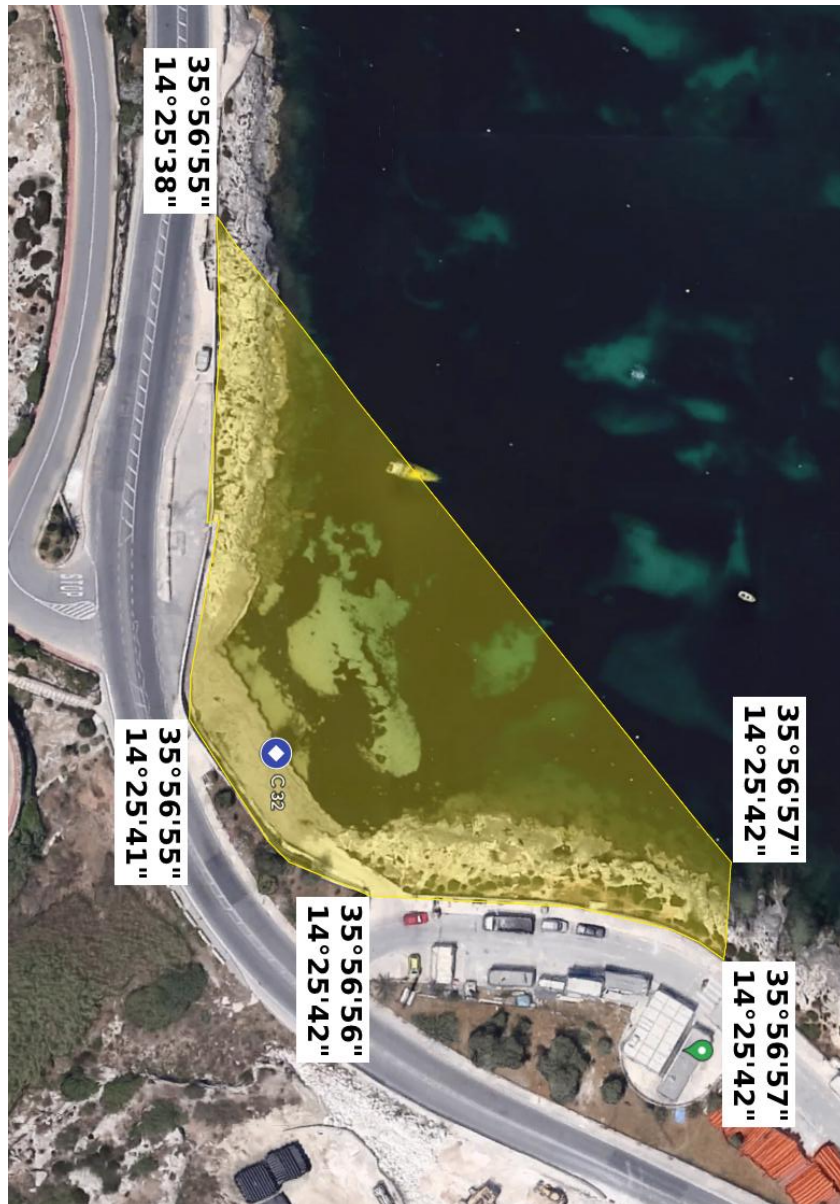
Figure 1 : GIS for the Official Bathing Area of C32

beach surrounded by rocky shore adjacent to Coast Road.

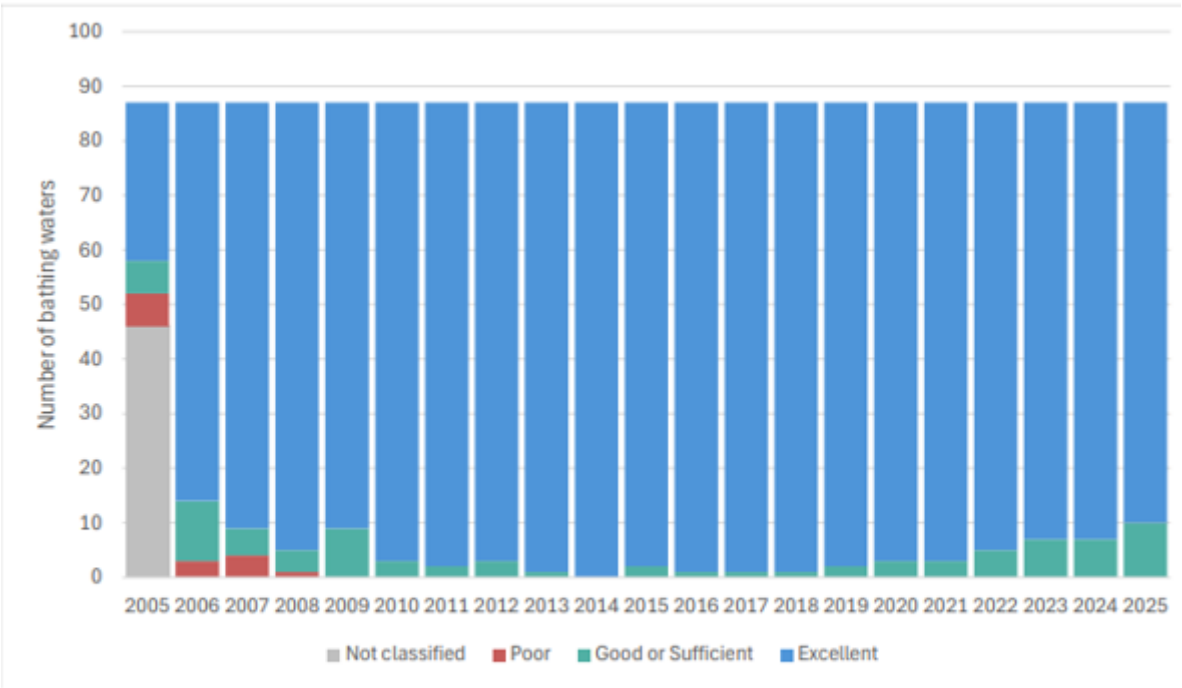
Figure 4: Results of bathing water quality in Malta from 2005 to 2025

Classification updated for the year 2025.

**Trend of coastal bathing water quality in Malta. Notes:** Each column represents an absolute number of bathing waters in the season. The ‘good’ and ‘sufficient’ quality classes are merged for comparability with the classifications under the preceding Bathing Water Directive 76/160/EEC.
