# Bathing Water Profile

PROFILE 21– Data updated for 2025

GHAJNSIELEM: Xatt l-Ahmar

SANNAT: Mgarr ix-Xini

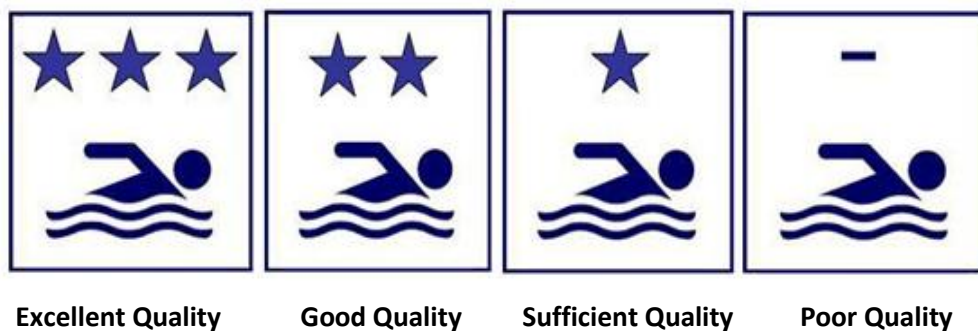
Figure 1: Star Classification

The bathing water quality is based on two microbiological parameters (Escherichia coli and Intestinal enterococci). These two parameters determine the classification of the bathing water quality as 'excellent', 'good', 'sufficient' or 'poor'. The symbols shown in **Figure 1** below correspond to this classification. The European Environment Agency report for the year 2025 indicated that 88.5% of the bathing water classified as excellent quality, see **Figure 4**. (European Environmental Agency, 2026).

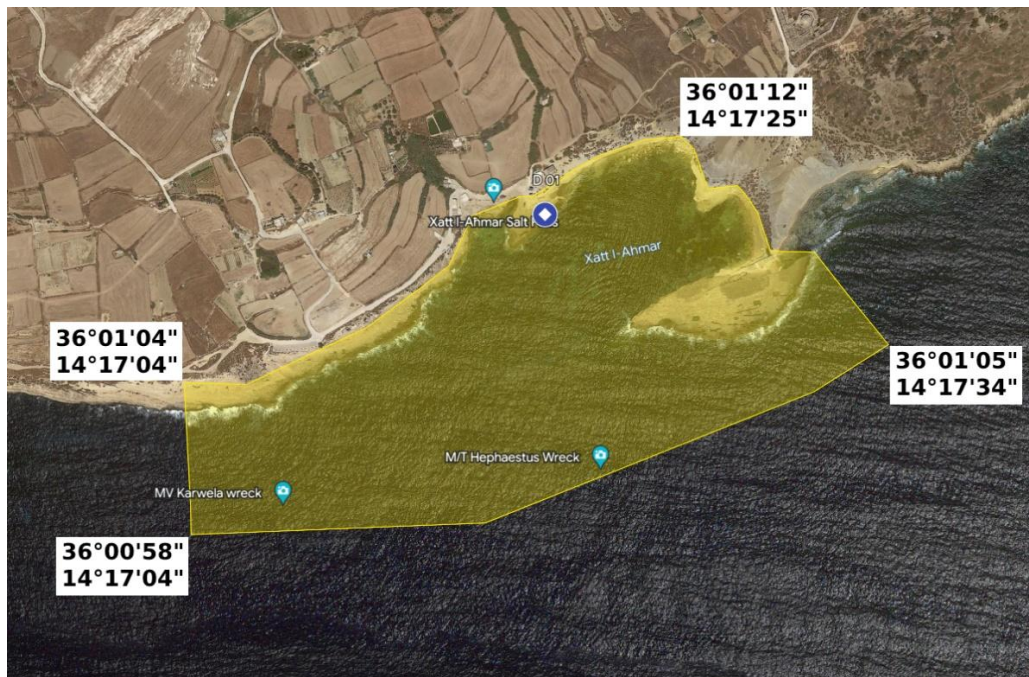
Figure 2: GIS for the Official Bathing Area of D01

Bathing water profile 21 covers 3 monitoring points situated in the locality of Ghajnsielem and Sannat as per **Figure 2 & 3 and Table 1**. These monitoring points are located along Gozo's southern coast. D01 in Ghajnsielem where it gets its name from the red quay as translated from "Xatt l-Ahmar". This is an ideal spot for both swimming and diving, mostly frequented by locals, known for the crystal water and beautiful coastal surroundings. Some

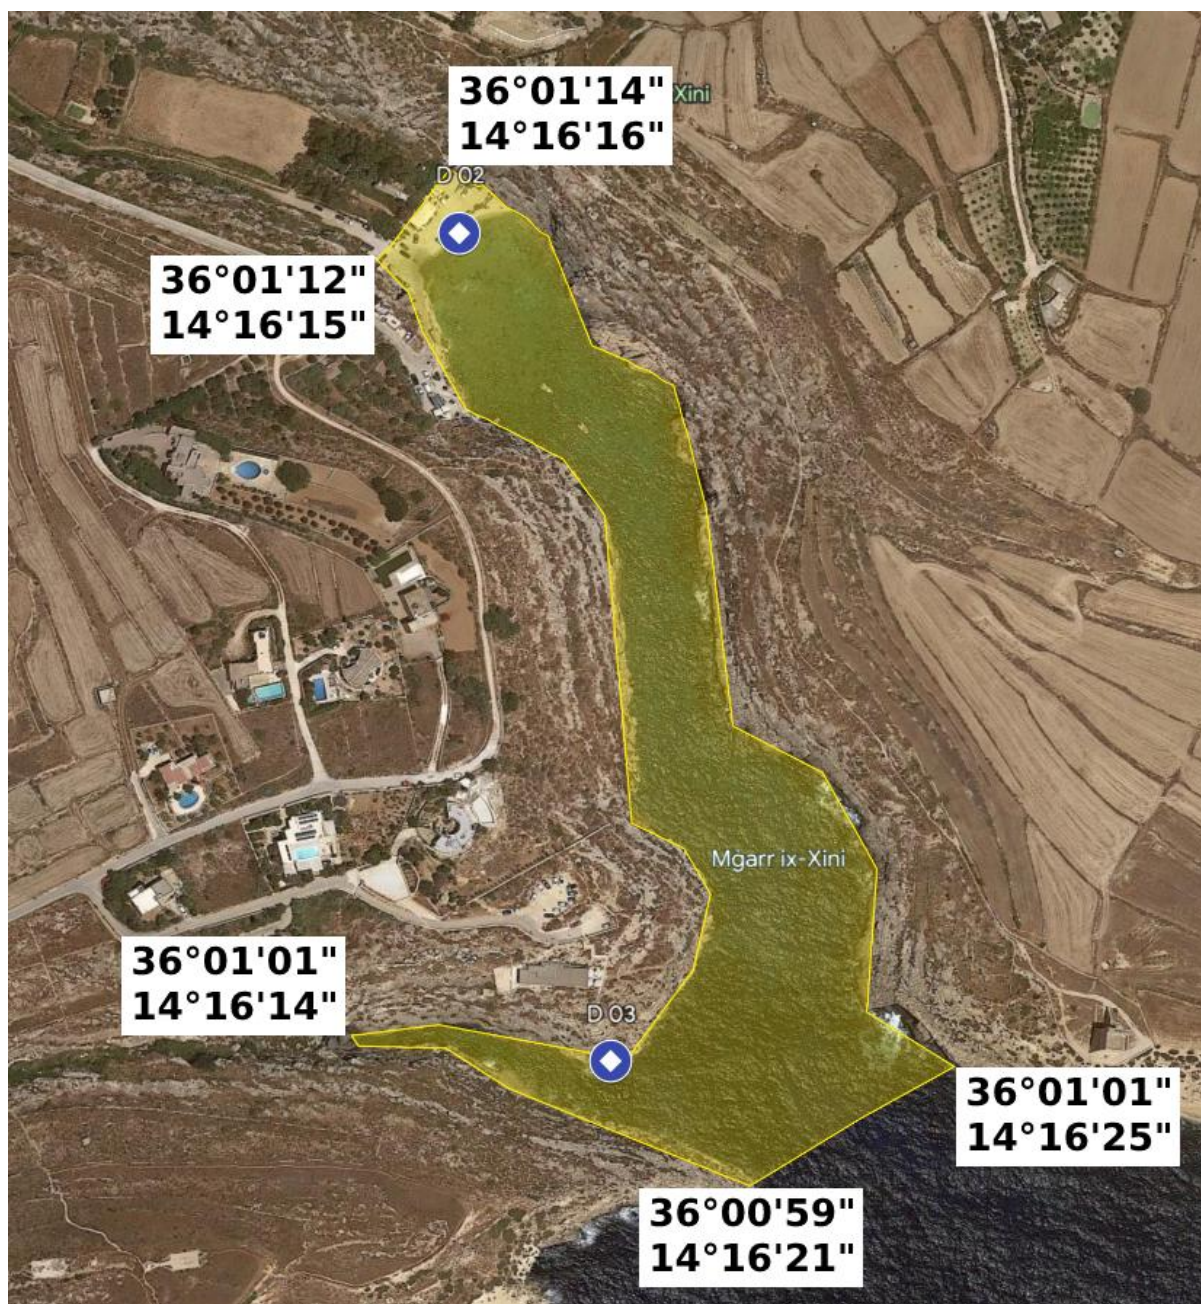
Figure 1: GIS for the Official Bathing Area of D02 & D03

boathouses are located in the area. D02 and D03 are found in the village of Sannat surrounded by natural landscaping and a small restaurant.

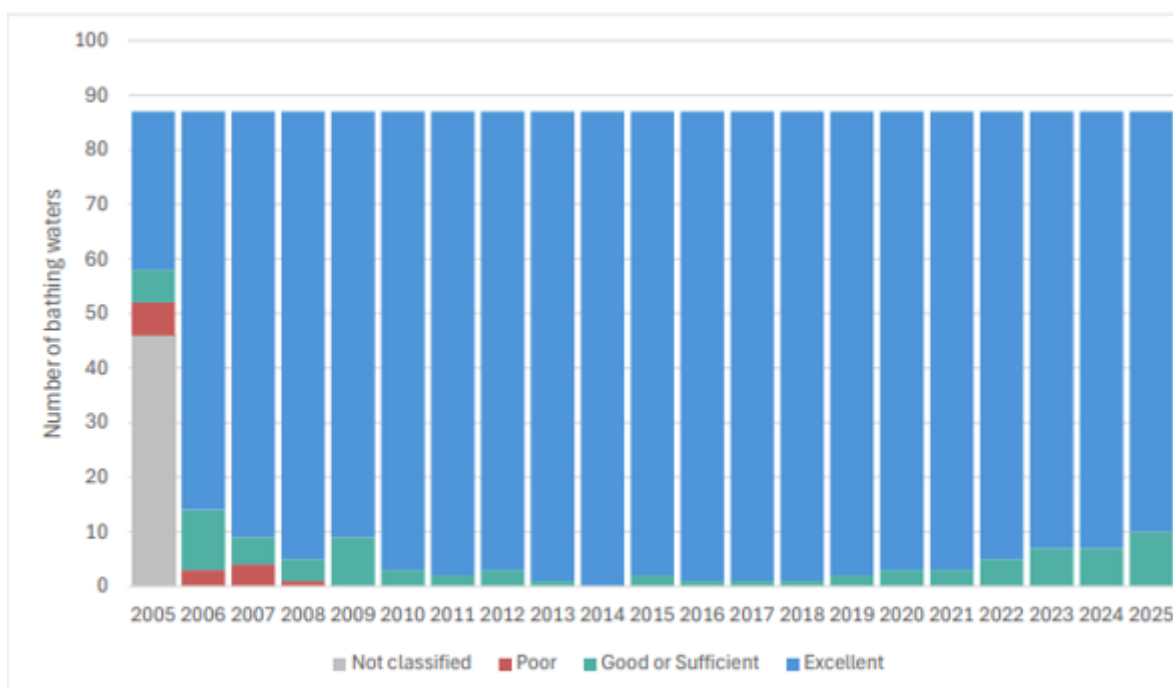
Figure 4: Results of bathing water quality in Malta from 2005 to 2025

**Trend of coastal bathing water quality in Malta.** Notes: Each column represents an absolute number of bathing waters in the season. The 'good' and 'sufficient' quality classes are merged for comparability with the classifications under the preceding Bathing Water Directive 76/160/EEC.
