# Bathing Water Profile

PROFILE 23 – Data updated for 2025

SAN LAWRENZ: Dwejra Inland Sea

## Update to the Bathing Water Profile based on the report by the European Environment Agency issued in May 2026

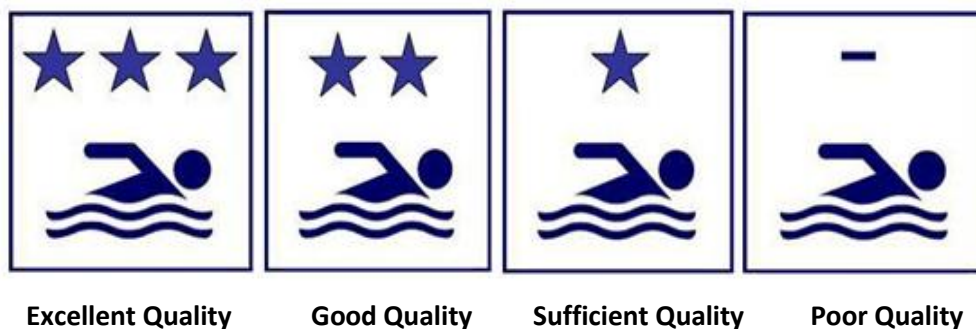
Figure 1: Star Classification

The bathing water quality is based on two microbiological parameters (Escherichia coli and Intestinal enterococci). These two parameters determine the classification of the bathing water quality as 'excellent', 'good', 'sufficient' or 'poor'. The symbols shown in **Figure 1** below correspond to this classification. The European Environment Agency report for the year 2025 indicated that 88.5% of the bathing water classified as excellent quality, see **Figure 3**. (European Environmental Agency, 2026).

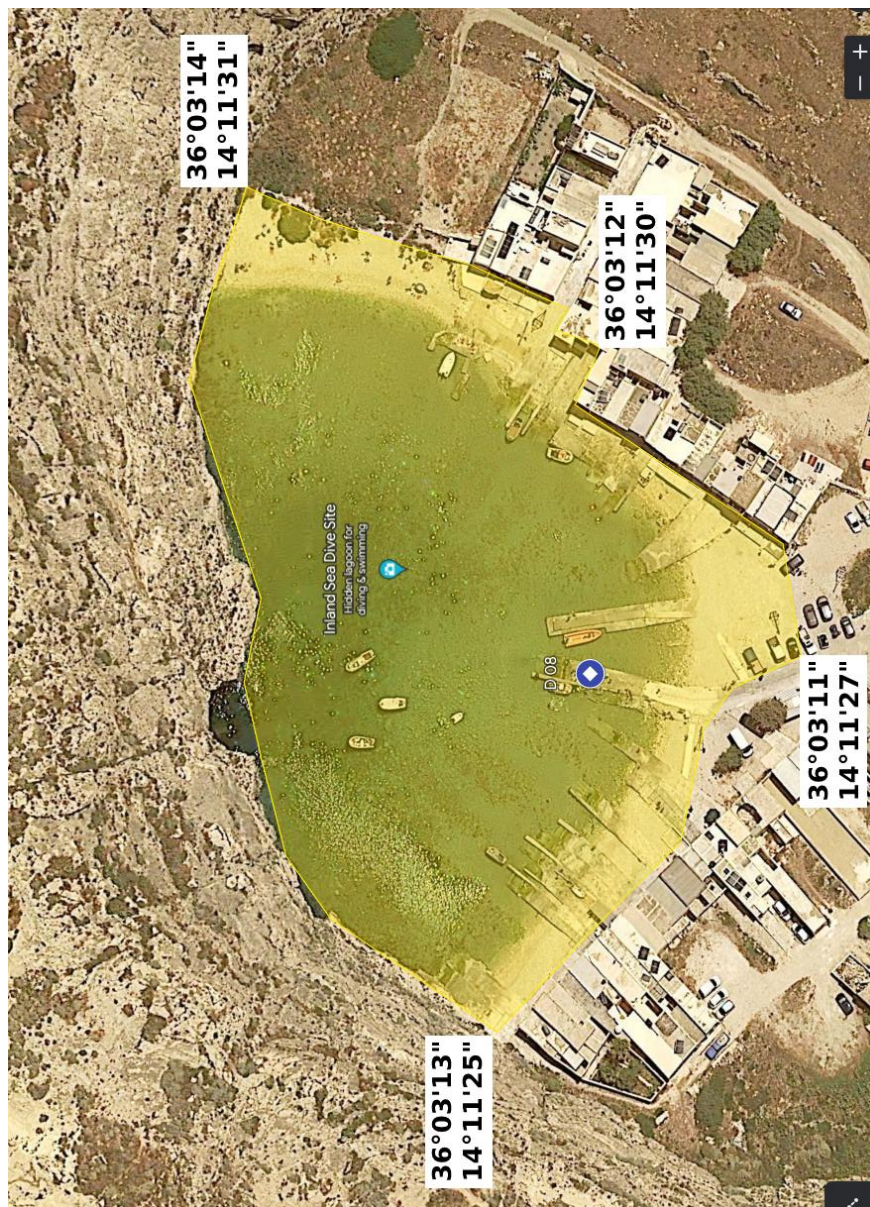
**Figure 2: GIS for the Official Bathing Area of D08**

Bathing water profile 23 covers 1 monitoring point situated in the locality of San Lawrenz as per **Figure 2 and Table 1**. Located along Gozo's western coast of San Lawrenz which is accessed either via a cave tunnel or through a road leading from the main parking area. It comprises of an enclosed pebble beach within Qawra's quasi-circular solution subsidence structure and the inland sea is relatively sheltered and not directly exposed to the coast. The terrestrial area at Dwejra has conserved most of its natural
