# Bathing Water Profile

PROFILE 25 – Data updated for 2025

ZEBBUG: Marsalforn Bay

## Update to the Bathing Water Profile based on the report by the European Environment Agency issued in May 2026

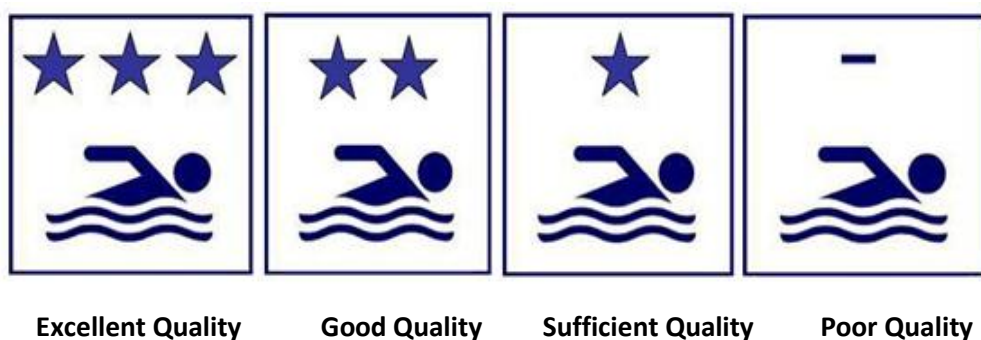
Figure 1: Star Classification

The bathing water quality is based on two microbiological parameters (Escherichia coli and Intestinal enterococci). These two parameters determine the classification of the bathing water quality as 'excellent', 'good', 'sufficient' or 'poor'. The symbols shown in **Figure 1** below correspond to this classification. The European Environment Agency report for the year 2025 indicated that 88.5% of the bathing water classified as excellent quality, see **Figure 3**. (European Environmental Agency, 2026).

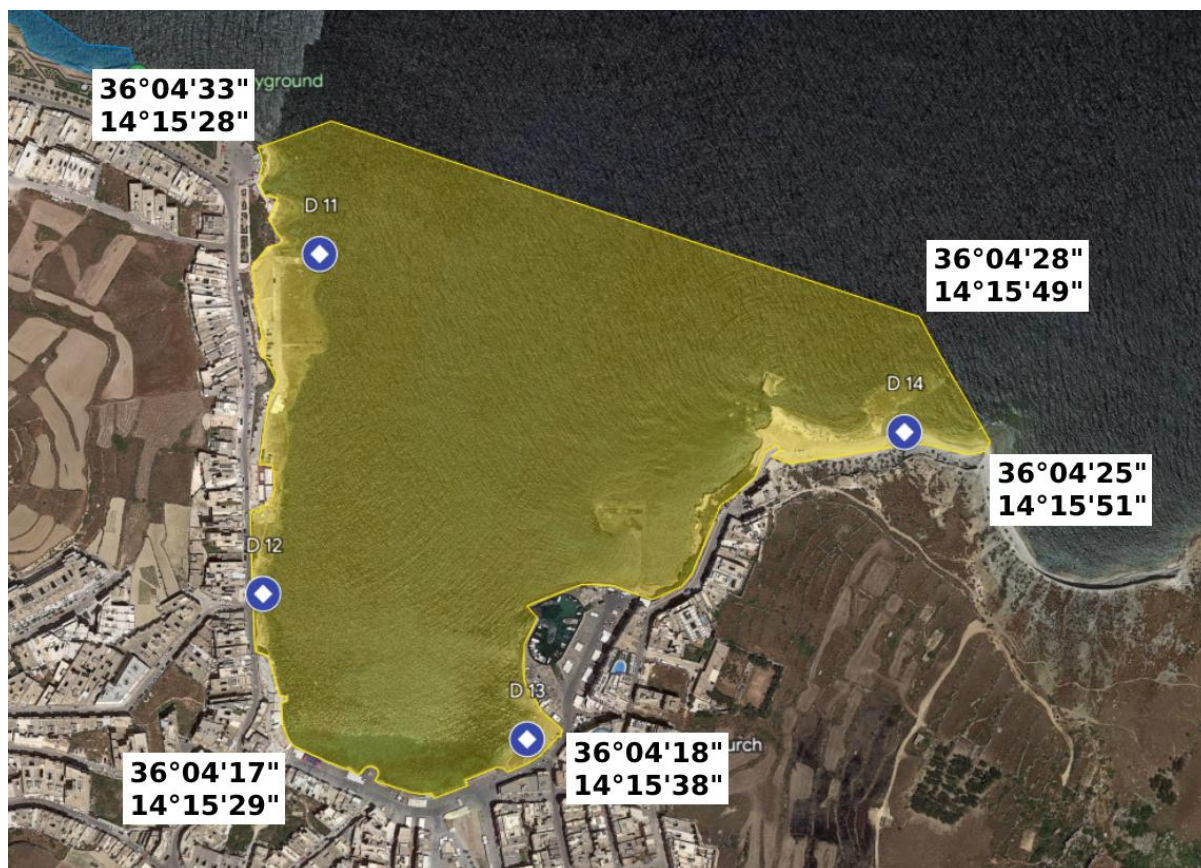
Figure 2: GIS for the Official Bathing Area of D11, D12, D13 & D14

Bathing water profile 25 covers 4 monitoring points situated in the locality of Zebbug as per **Figure 2 and Table 1**. A sandy beach with small pebbles backed by a promenade which runs right around the head of the bay. The rocks along each side of the bay provide plenty of additional space for sunbathing and swimming straight into deeper water. A number of marine,

The monitoring points D11, D12, D13 & D14 have been monitored for 23 weeks, by the Environmental Health Directorate. The monitoring period for the official bathing season starts on the third week of May till the third week of October. For the year 2025 the monitoring day where 12<sup>th</sup> May till 19<sup>th</sup> October.

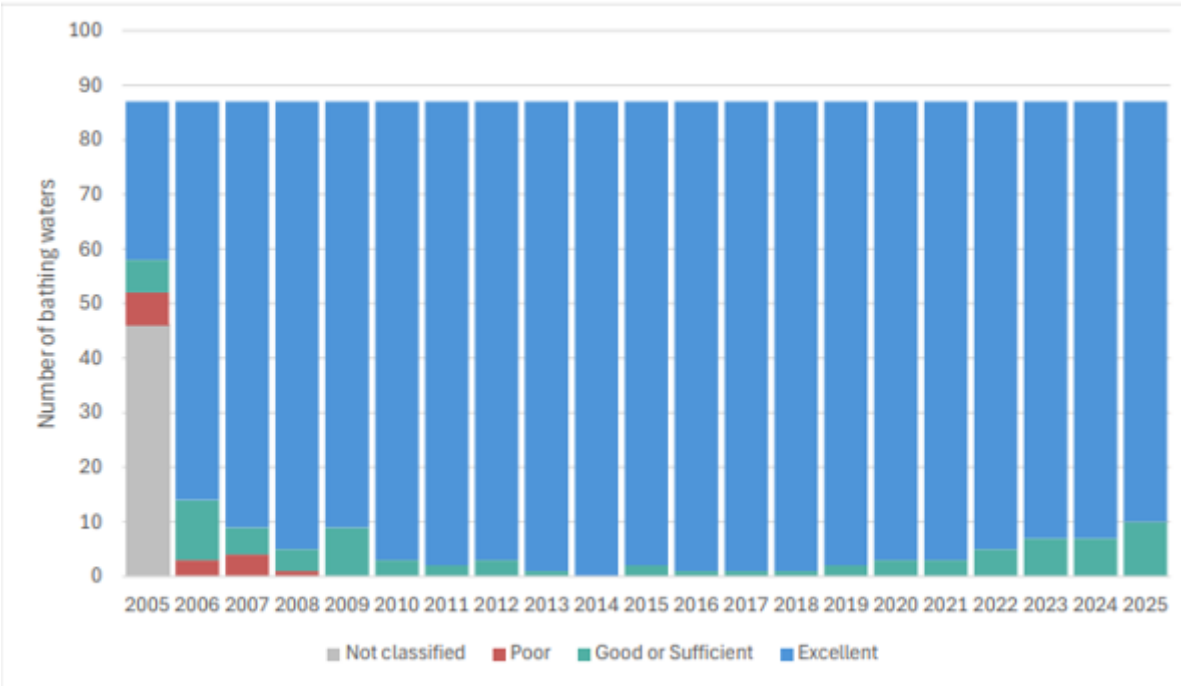
Figure 3: Results of bathing water quality in Malta from 2005 to 2025

Classification updated for the year 2025.

**Trend of coastal bathing water quality in Malta.** Notes: Each column represents an absolute number of bathing waters in the season. The ‘good’ and ‘sufficient’ quality classes are merged for comparability with the classifications under the preceding Bathing Water Directive 76/160/EEC.
