# Bathing Water Profile

PROFILE 27– Data updated for 2025

QALA: Hondoq ir-Rummien

GHAJNSIELEM: Zewwieqa Bay.

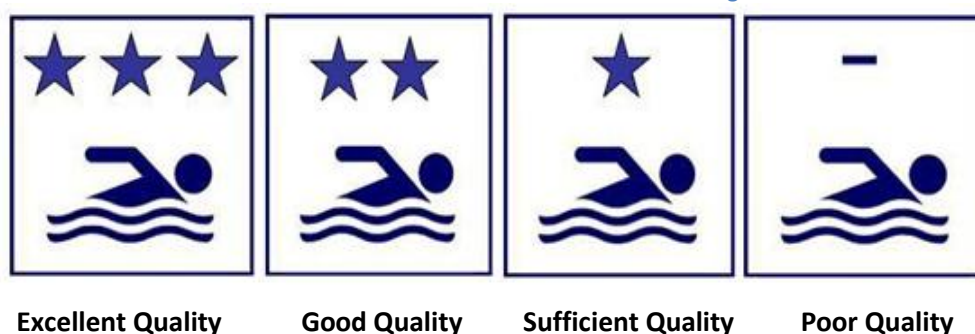
Figure 1: Star Classification

The bathing water quality is based on two microbiological parameters (Escherichia coli and Intestinal enterococci). These two parameters determine the classification of the bathing water quality as 'excellent', 'good', 'sufficient' or 'poor'. The symbols shown in **Figure 1** below correspond to this classification. The European Environment Agency report for the year 2025 indicated that 88.5% of the bathing water classified as excellent quality, see **Figure 4**. (European Environmental Agency, 2026).

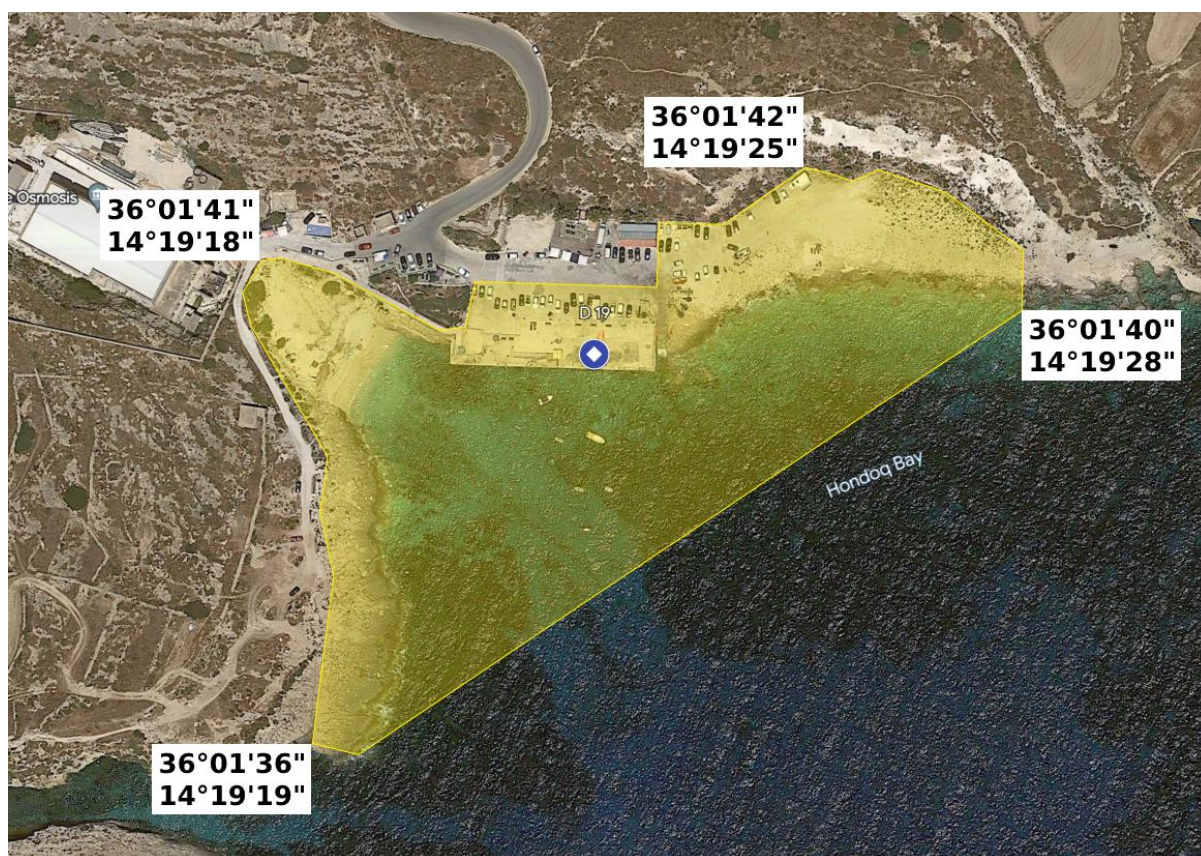
Figure 2: GIS for the Official Bathing Area of D19

Bathing water profile 27 covers 2 monitoring points situated in the locality of Qala and Ghajnsielem as per **Figure 2 & 3 and Table 1**. Located along Gozo's southern coast. Hondoq ir-Rummien, a typical rocky beach with a small sandy and pebbled area. The area isn't highly urbanised and is located in an unspoilt and natural setting. This bay provides several water sports activities such as wind surfing, diving and yachting. Zewwieqa Bay is adjacent to the
