# Bathing Water Profile

PROFILE 29 – Data updated for 2025

COMMUNO: San Niklaw Bay

Santa Marija Bay

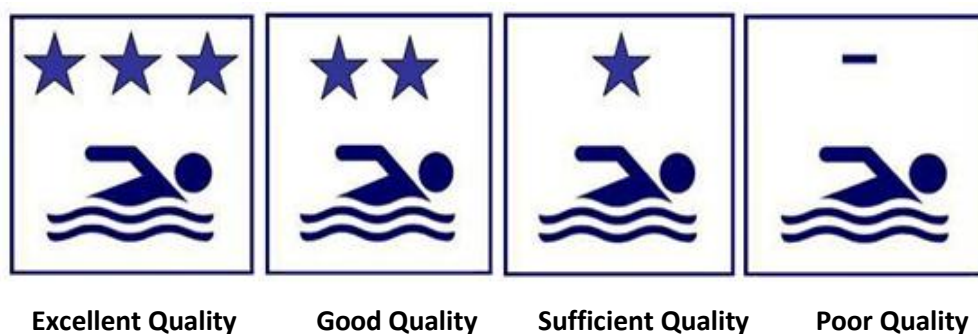
Figure 1: Star Classification

The bathing water quality is based on two microbiological parameters (Escherichia coli and Intestinal enterococci). These two parameters determine the classification of the bathing water quality as 'excellent', 'good', 'sufficient' or 'poor'. The symbols shown in **Figure 1** below correspond to this classification. The European Environment Agency report for the year 2025 indicated that 88.5% of the bathing water classified as excellent quality, see **Figure 4**. (European Environmental Agency, 2026).

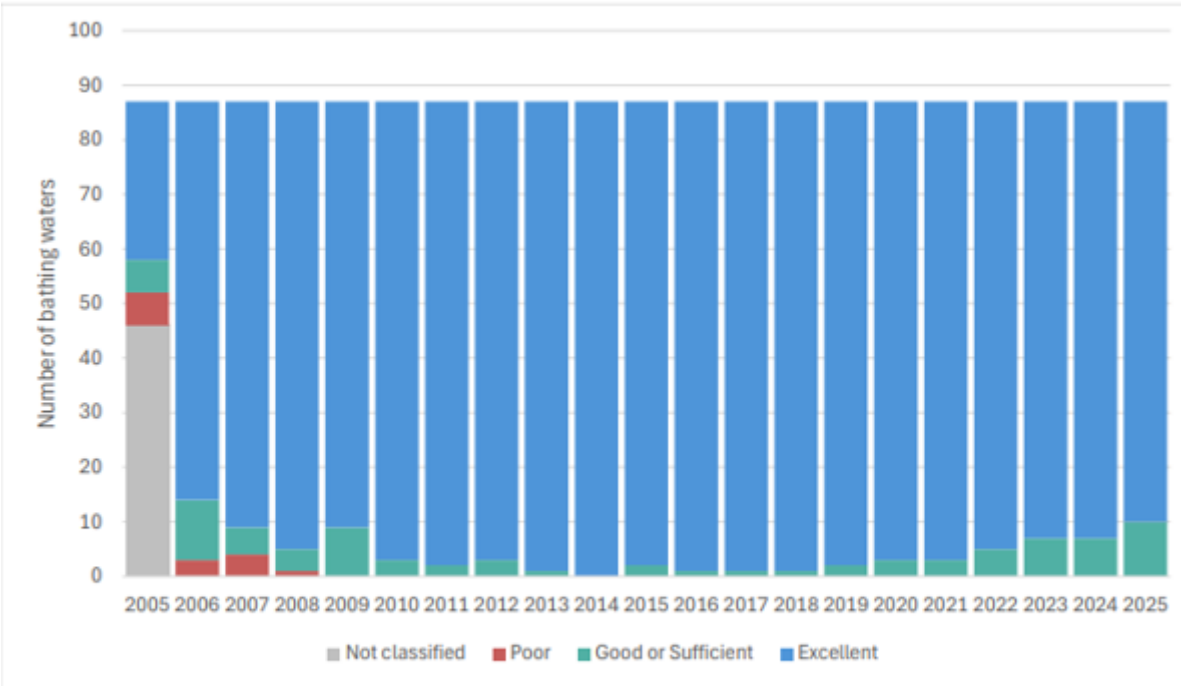
Figure 4: Results of bathing water quality in Malta from 2005 to 2025

**Trend of coastal bathing water quality in Malta. Notes:** Each column represents an absolute number of bathing waters in the season. The ‘good’ and ‘sufficient’ quality classes are merged for comparability with the classifications under the preceding Bathing Water Directive 76/160/EEC.
