**REPORT ON THE TEMPORARY CLOSURE DUE TO BATHING PROHIBATION  
PERIOD  
C23 Il-Bajja tal-Ghazzenin St Pauls Bay  
(26/06-3/07/2026)**

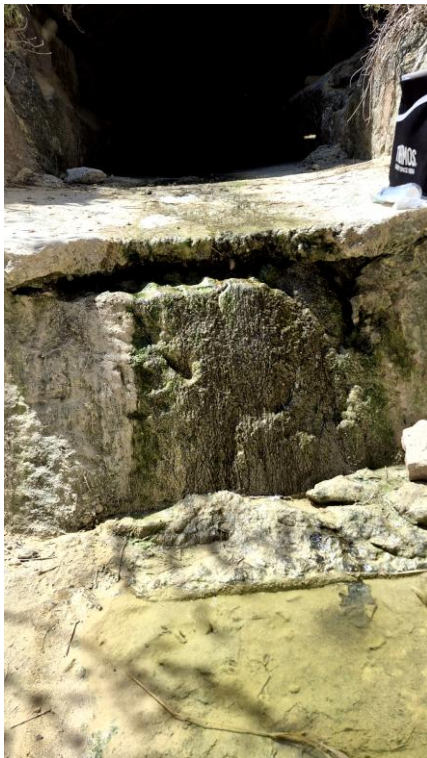
An on-site investigation was carried out on the same day by Environmental Health Officers (EHOs), who confirmed the presence of sewage overflowing into the sea (see Figure 1). A dye test was conducted by the EHOs in the presence of Water Services Corporation (WSC) personnel in one of the main sewers located in the vicinity of the tunnel, (see Figure 2).

*Figure 1: foul water form tunnel*

Subsequently, the WSC undertook the necessary remedial works, which included the replacement of the defective sewer section, as shown in figures 3 to 6. Following completion of these works, the sewage overflow ceased.

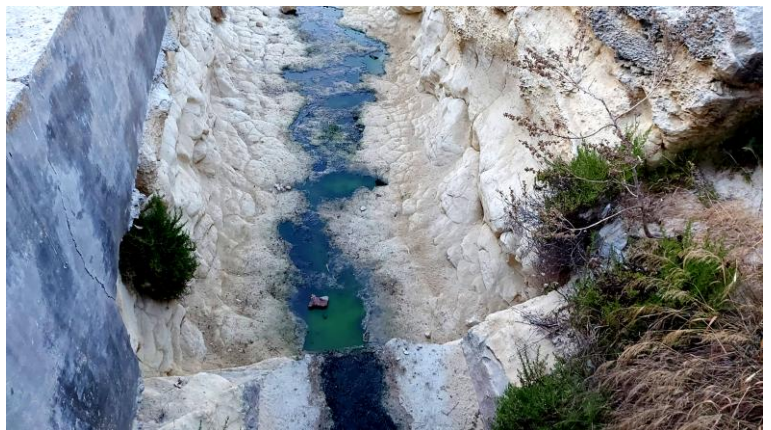
The test confirmed that the overflow originated from a defective main sewer.

*Figure 2: Green Dye carried out from main sewer*

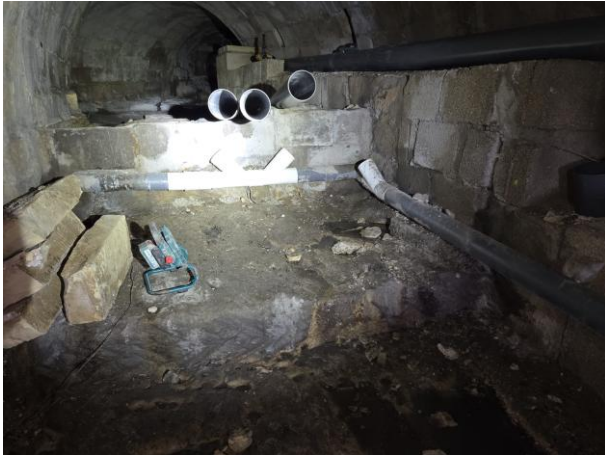
*Figure 3: Change of main sewer inside the tunnel*

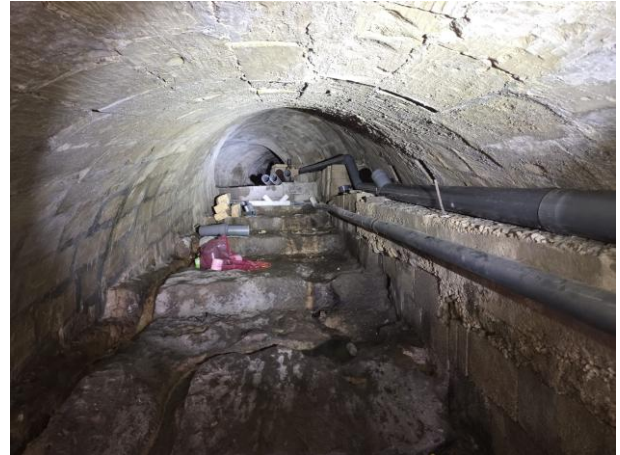
*Figure 4: change of main sewer inside the tunnel*

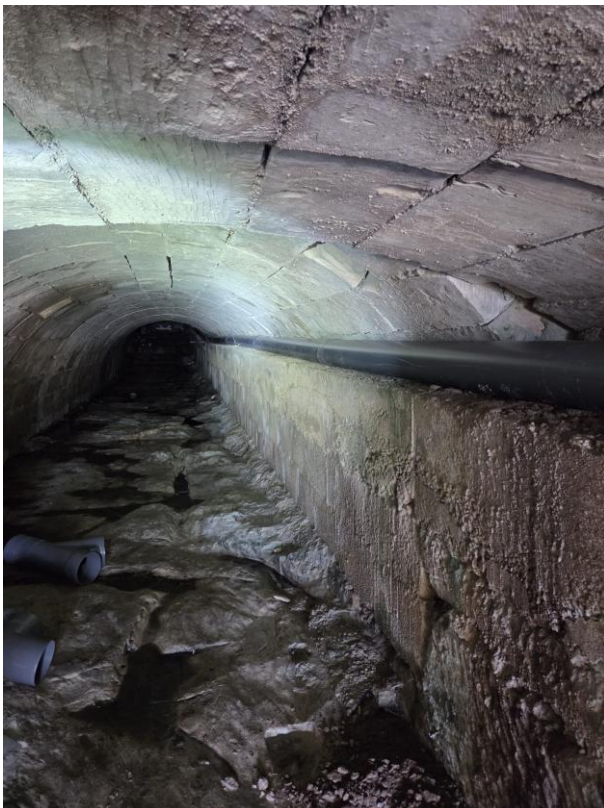
*Figure 5: change of main sewer inside the tunnel*

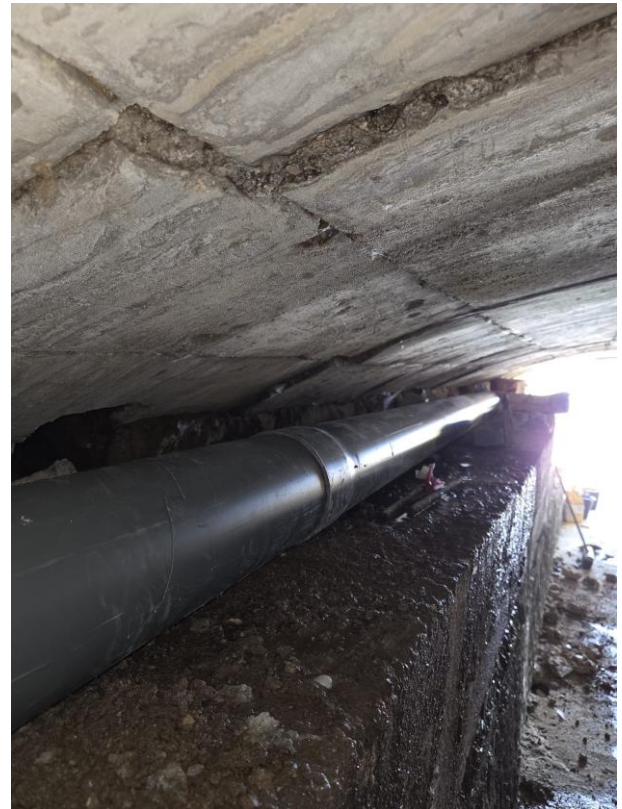
*Figure 6: change of main sewer inside the tunnel*

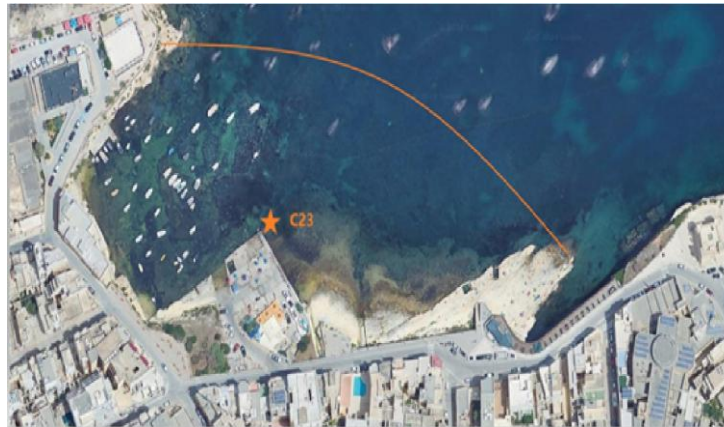
The map in Figure 7 indicates the affected area.

Figure 3: Site map of effected area

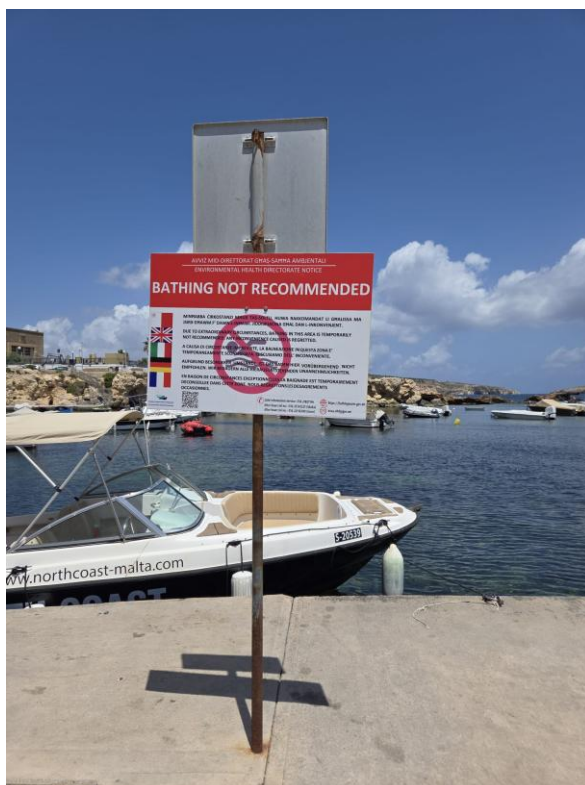
Public information signs indicating that the bathing area is temporary closed were also affixed by the EHOs (as per Figures 8 and 9). The Environmental Health Directorate's Bathing Water Portal was also updated to mark the effected area.

Figure 8: Sign not recommended for bathing

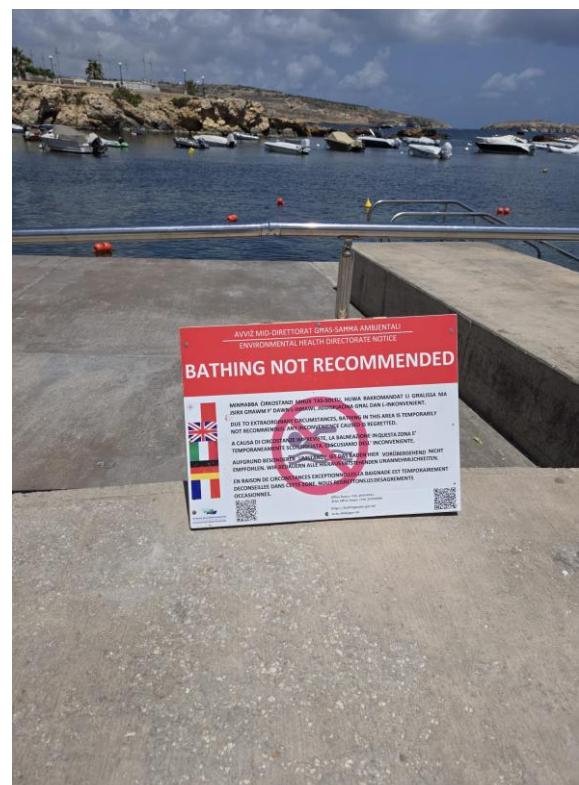
Figure 9: sign not recommended for bathing
